UNDERWATER BRIDGE INSPECTION REPORT

STRUCTURE NO. 27537

1ST AVENUE

EAST CHANNEL OF THE MISSISSIPPI RIVER

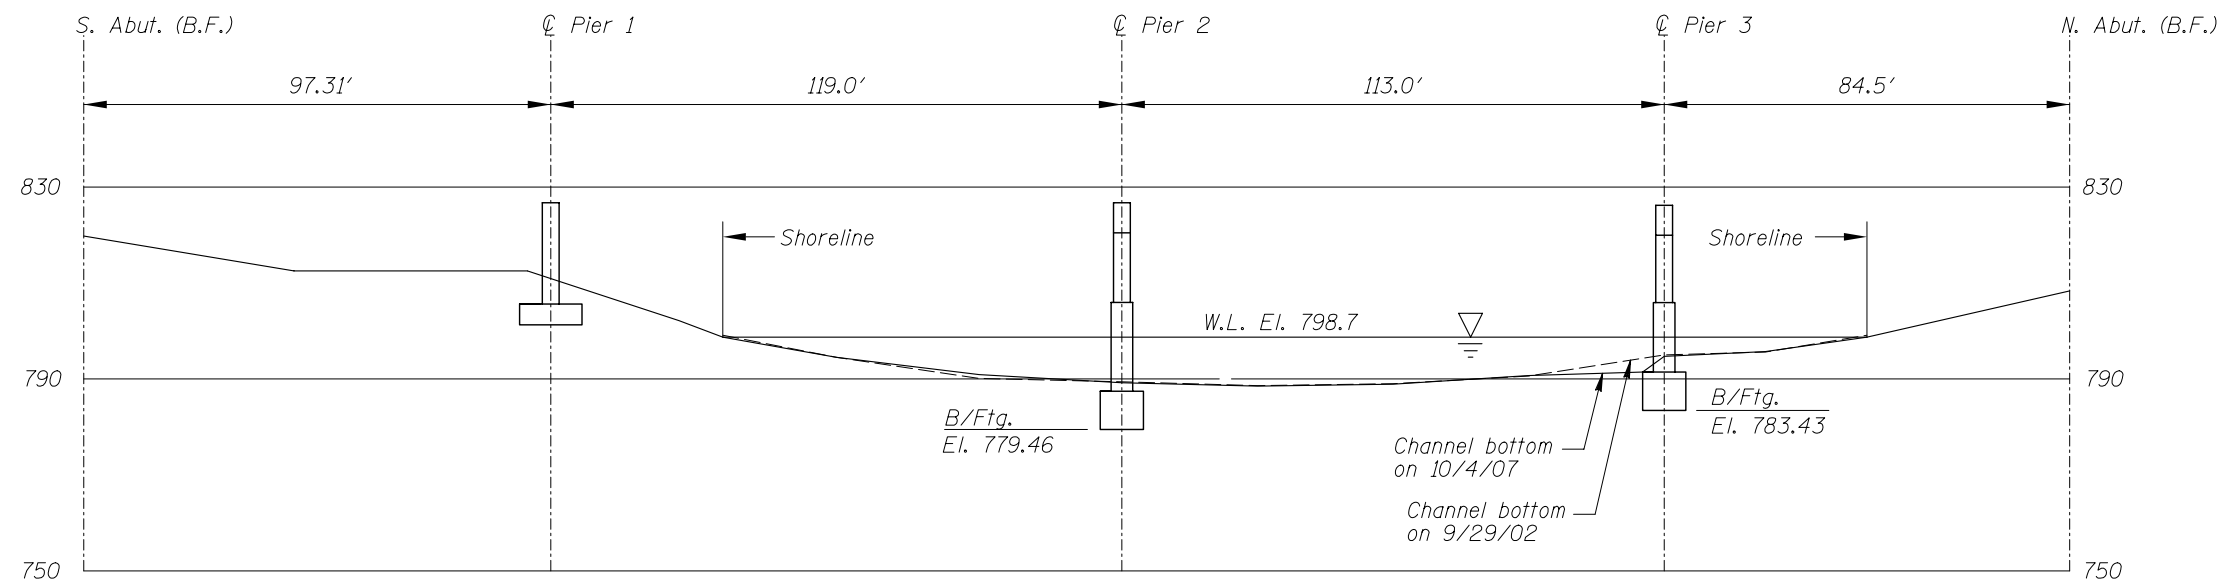
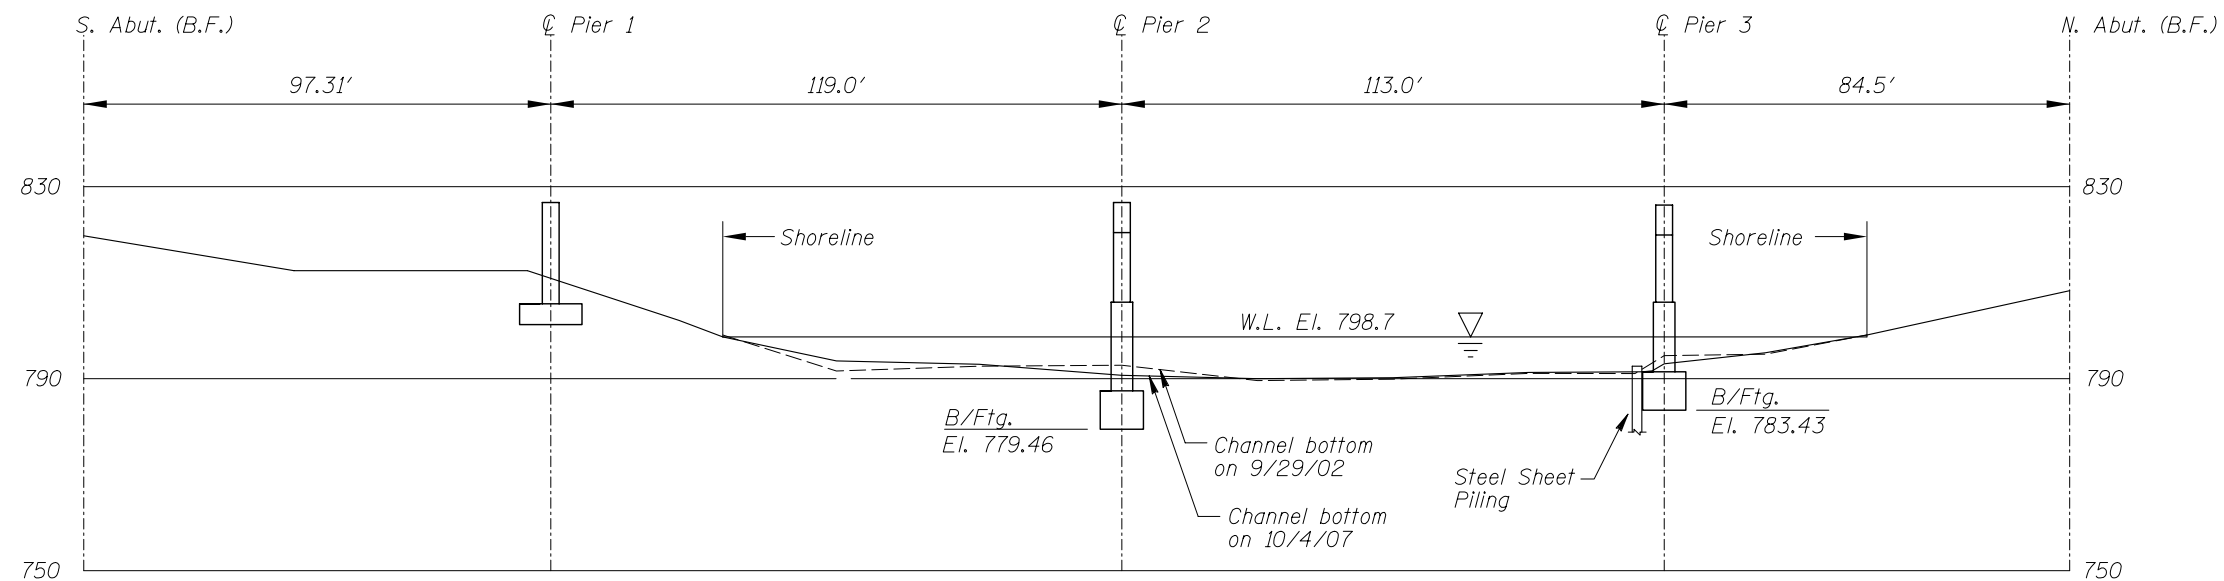
INSPECTION AND SOUNDING PLAN

- A moderate to heavy accumulation of timber debris was observed at the upstream end of Pier 2 on the channel bottom, consisting of 1-to-2-foot-diameter and smaller logs and branches that extended towards the west shore.

- A light accumulation of timber debris, consisting of 1 foot-diameter, logs and branches was observed at the upstream end of Pier 3.
- Both embankments were well armored with grouted riprap.

- Vertical cracks 1/16 inch wide were observed along the west face of Pier 3, extending from channel bottom to top of pier shaft.
- Overall concrete was smooth and sound.

- Footing exposure (top at 6.2 feet below waterline) was observed at the west face of Pier 3. The footing's surface was rough with some irregularities. Steel sheet piling was observed along footing from the midpoint to the downstream nose with a maximum vertical exposure of 1 foot (footing and sheeting).

- Vertical cracks (1/16 inch maximum width) were observed along east face (5 cracks) and west face (3 cracks) of Pier 2, extending from channel bottom to top of pier shaft.

Monitor the timber debris at Piers 2 and 3, and if found to be increasing in the future, removal operation may become warranted.

Reinspect the submerged substructure units at the normal maximum recommended (NBIS) interval of five (5) years.
